# Letting the Stream find its way again

*Reconnecting a tributary of  
the Anacostia River through  
regenerative stream design*

April 2026

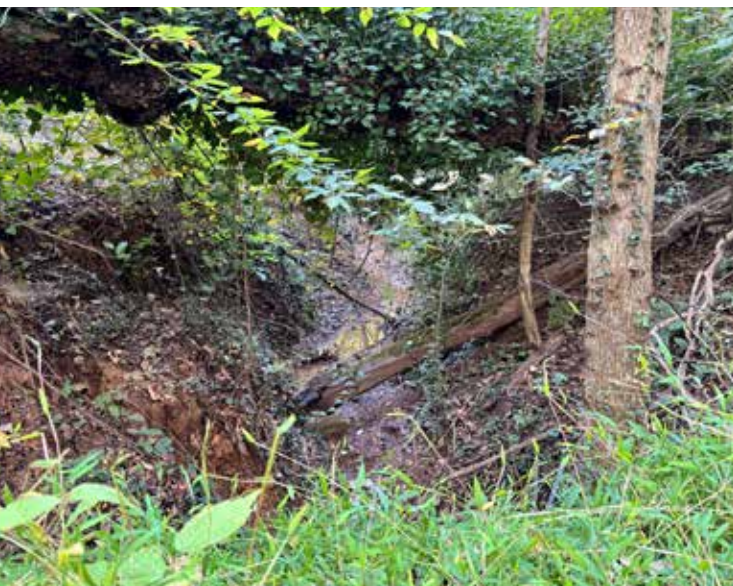
*Confined stream corridor at Fort DuPont Stream.*

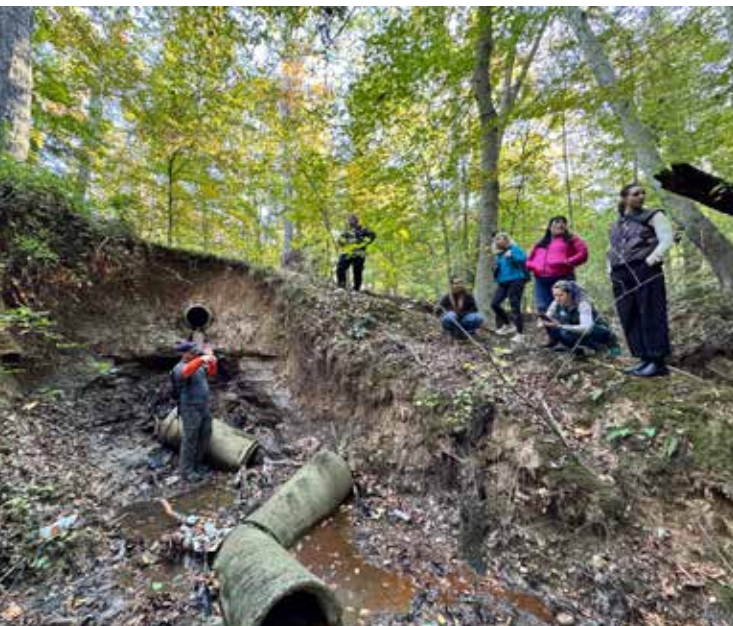
*This exposed culvert is just one example of the impacts resulting from channel instability.*

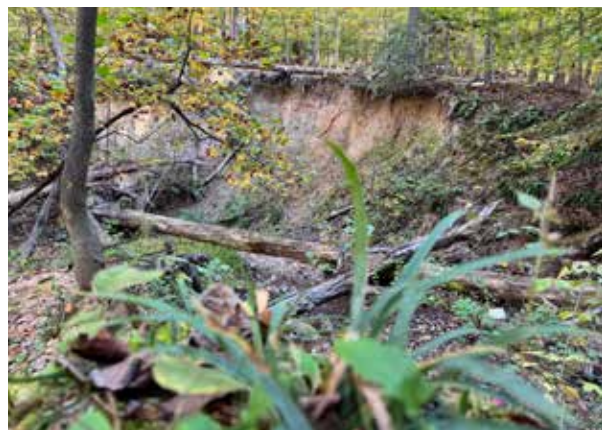
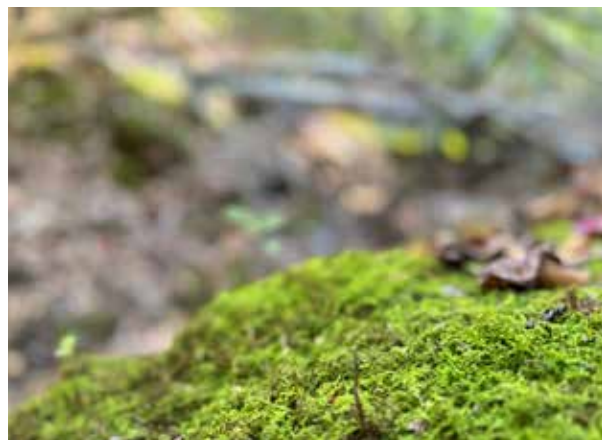
*Vegetation communities will naturally evolve as soils become wetter, a sign the restoration is working as intended.*

The stream's incision over time lowered the water table beneath the floodplain, allowing upland tree species such as tulip poplar (*Liriodendron tulipifera*) to establish in areas that would otherwise support wetland and riparian vegetation. As the streambed is raised and floodplain inundation is restored, those species may struggle to adapt to wetter conditions. Their decline, where it occurs, reflects the hydrology returning toward its natural state. The restoration plan includes planting thousands of native trees, shrubs, and herbaceous species suited to the restored floodplain conditions. Over time, these plant communities are expected to improve overall ecosystem diversity and function.
